**TRANSPORTATION RESEARCH CENTER**

**ON-SITE AIR BAG INVESTIGATION**

CASE NO. - 90-01  
FLEET - PRIVATE VEHICLE  
LOCATION - [REDACTED] INDIANA  
ACCIDENT DATE - [REDACTED] 1990

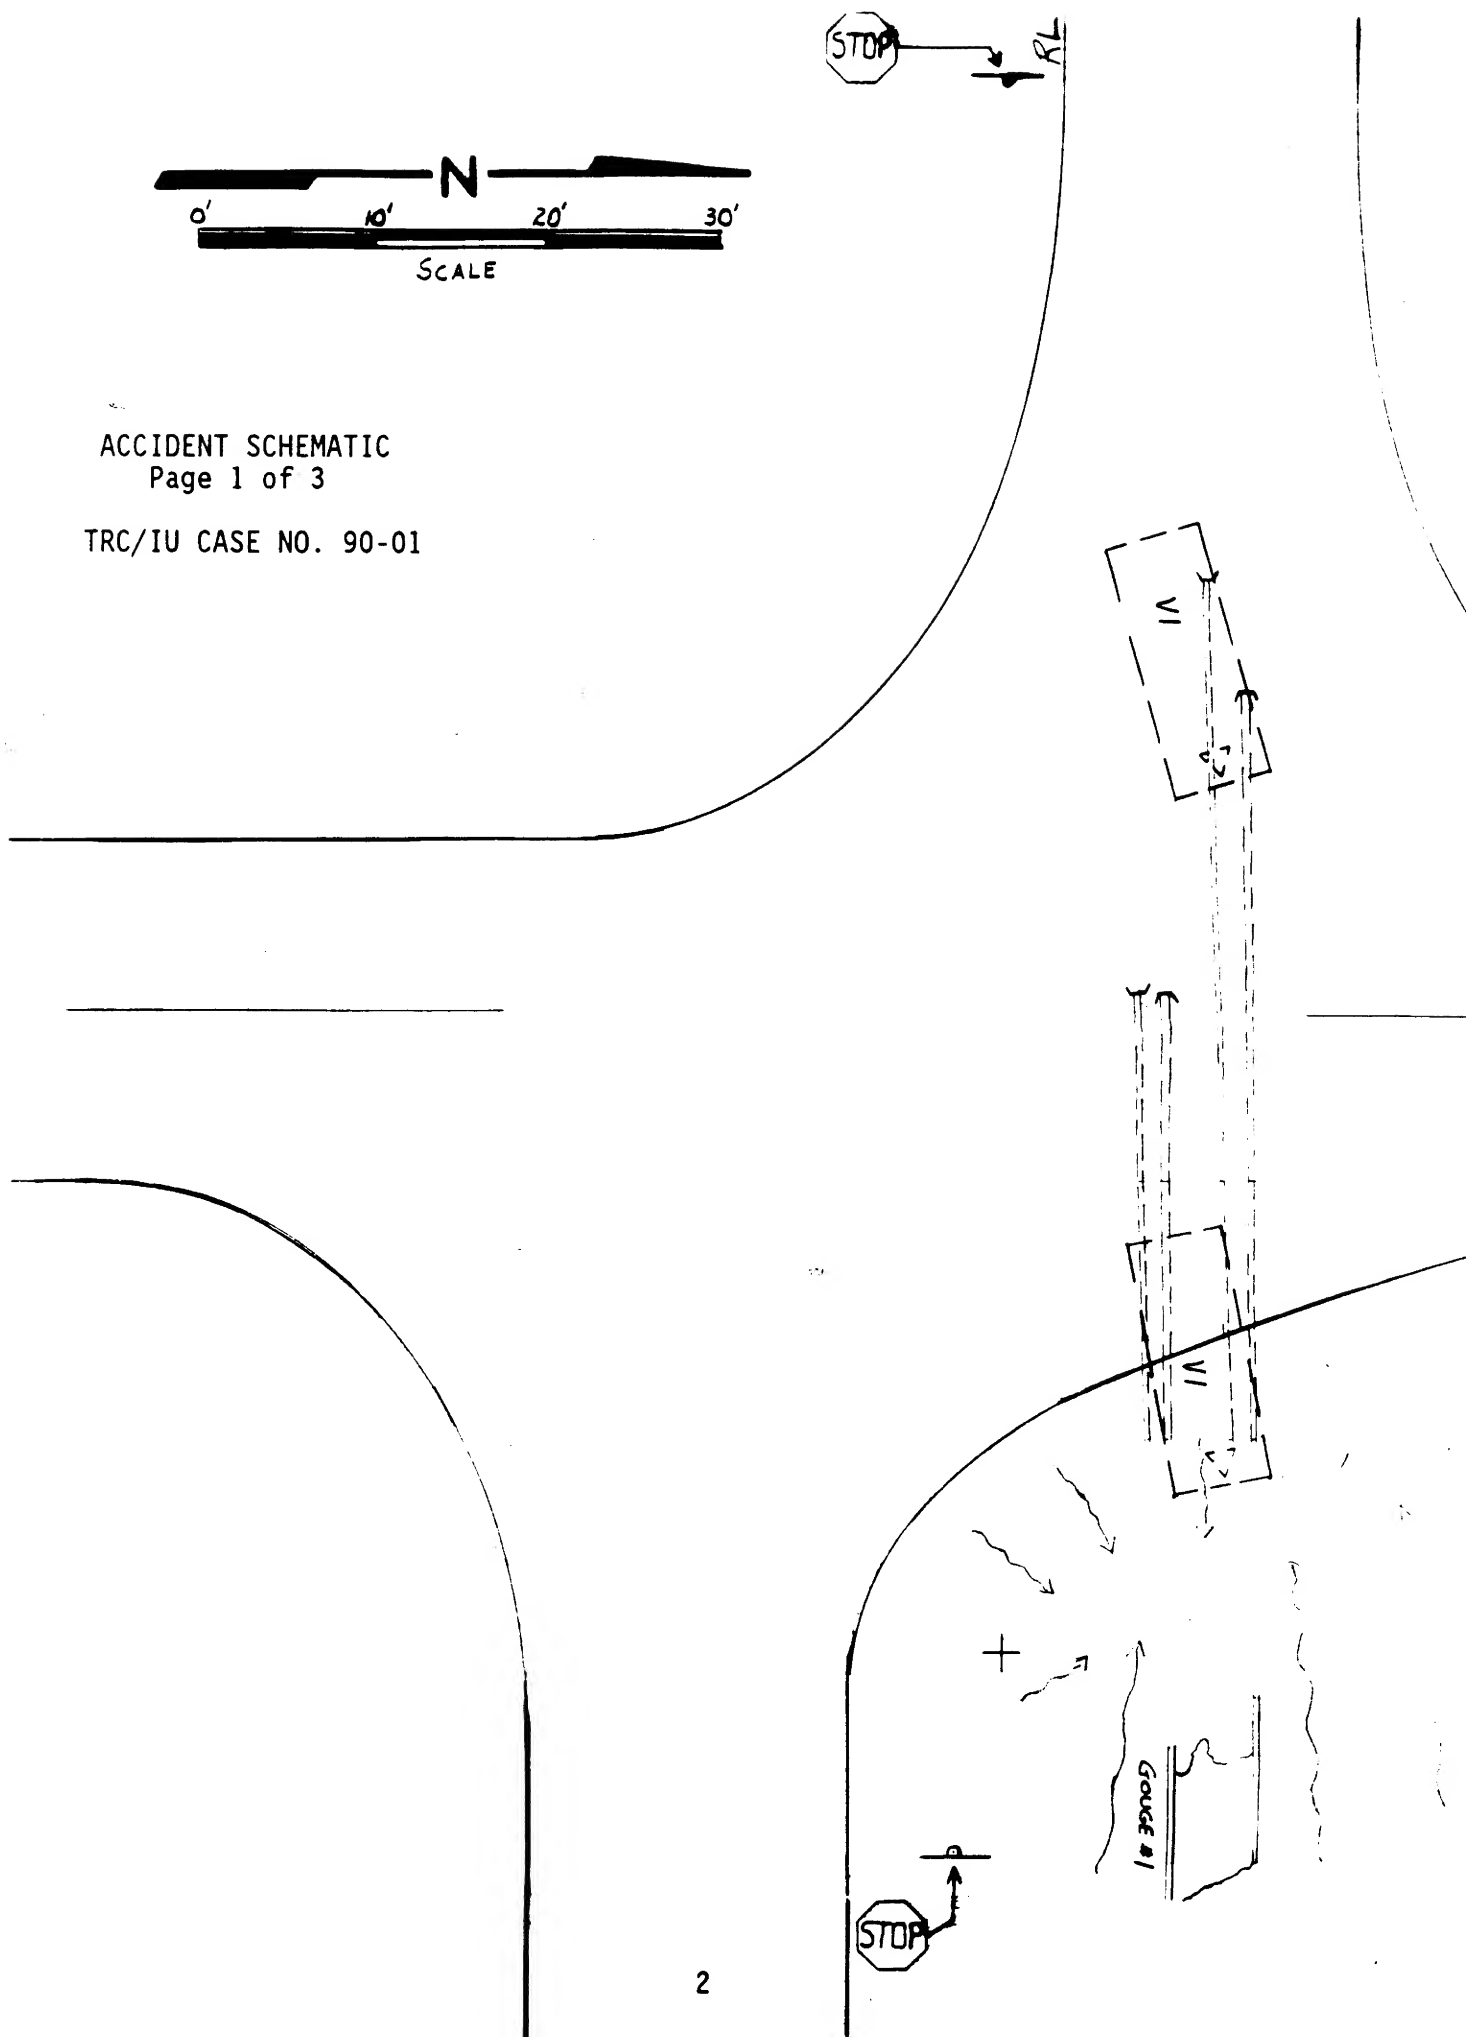
ACCIDENT SCHEMATIC  
Page 1 of 3

As the vehicle continued to rotate: (1) pitching forward an additional 180 degrees and (2) rolling an additional 180 degrees counterclockwise, it struck the ground "standing-on-its-tail". This impact caused the rear spoiler to bury into the ground and the backlight to disintegrate. At or somewhere prior to this point, the sunroof came open. The driver moved toward the roof and is believed to have been ejected at or near this time.

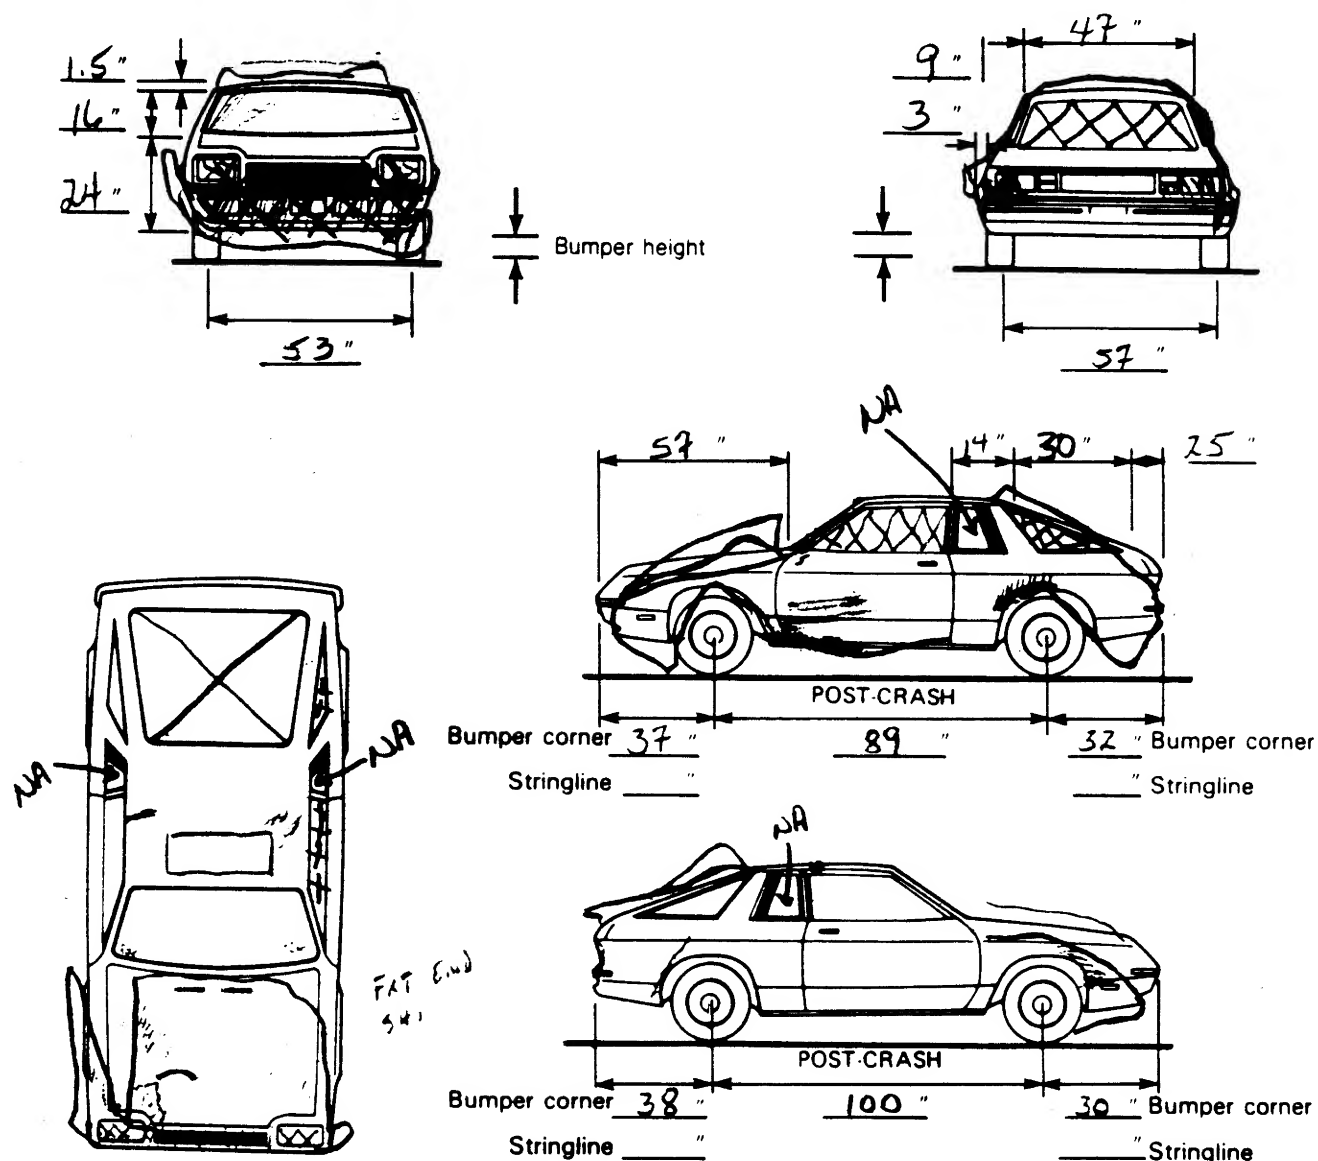
## VEHICLE DAMAGE SKETCH

Damaged Components: Front splashpan, left-front tire and wheel, left-front wheel well guard, left-front control arm, oil pan, dual exhaust system, bottom of rocker panels, dual mufflers, and gas tank.

Damaged Components: Windshield; left-front door glass; left-rear window glass; backlight glass; hood; front bumper; front headlights; front grille; left-front: fender, door, outside mirror; sunroof (missing); hatchback; right-front fender; rear spoiler (missing); rear taillights; rear bumper, left-rear quarter panel.

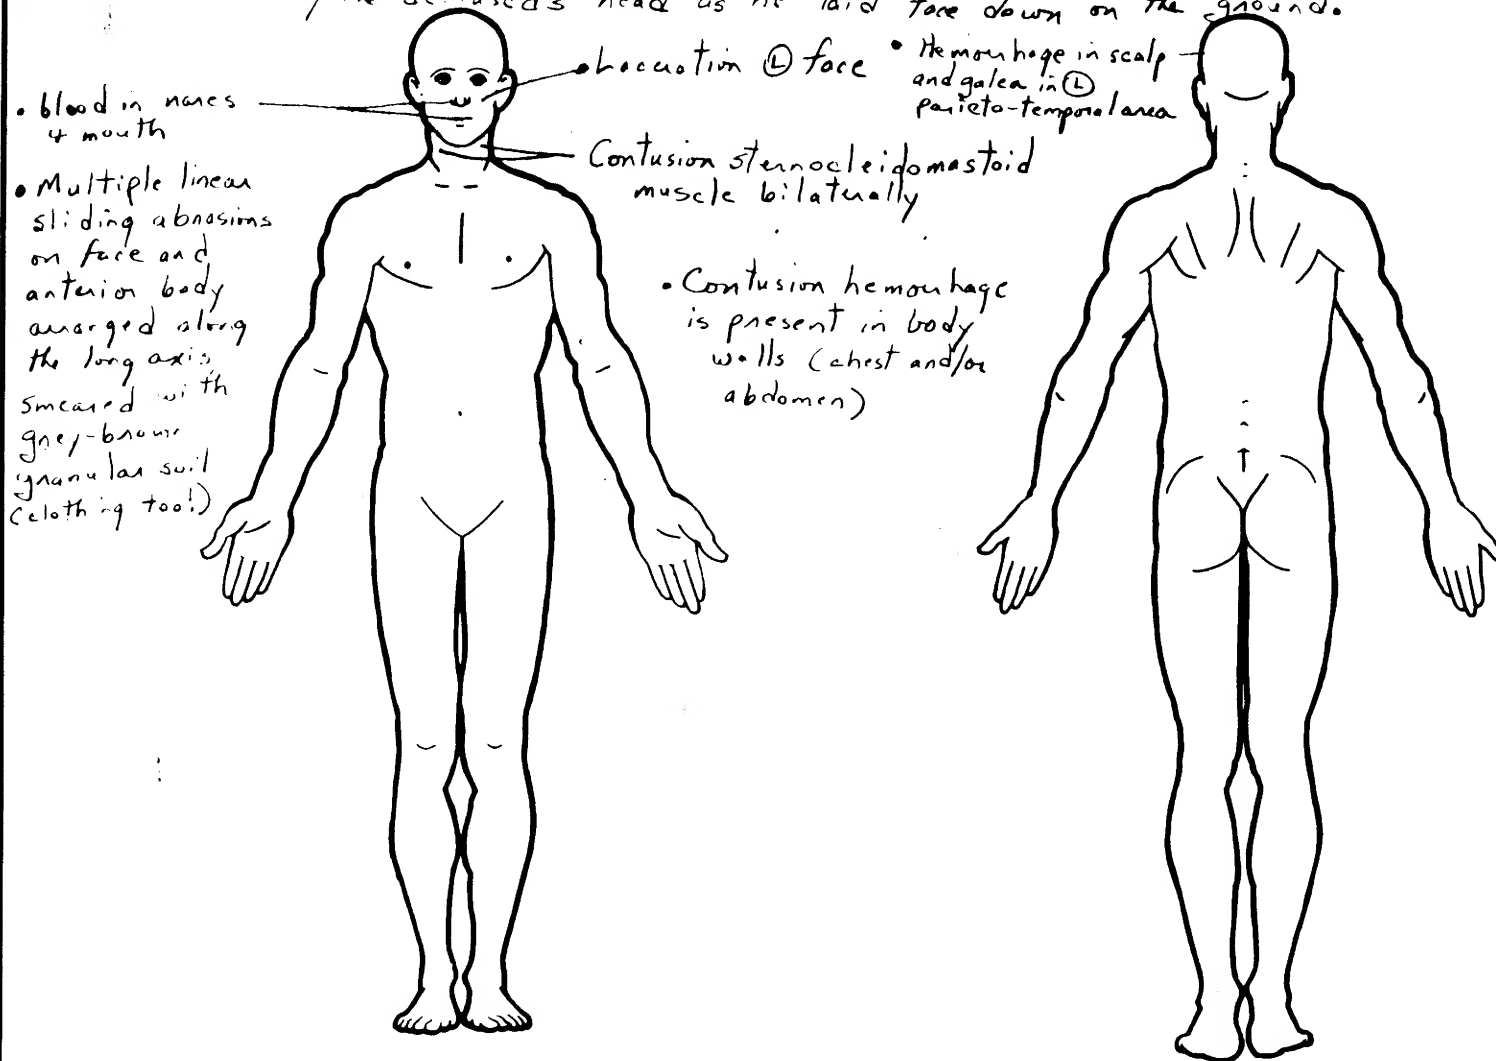
- Ejected through sun roof. Vehicle landed partially on top of body. The front bumper was at the back of the deceased's head as he laid face down on the ground.

Cause of Death: ... injury of head & chest

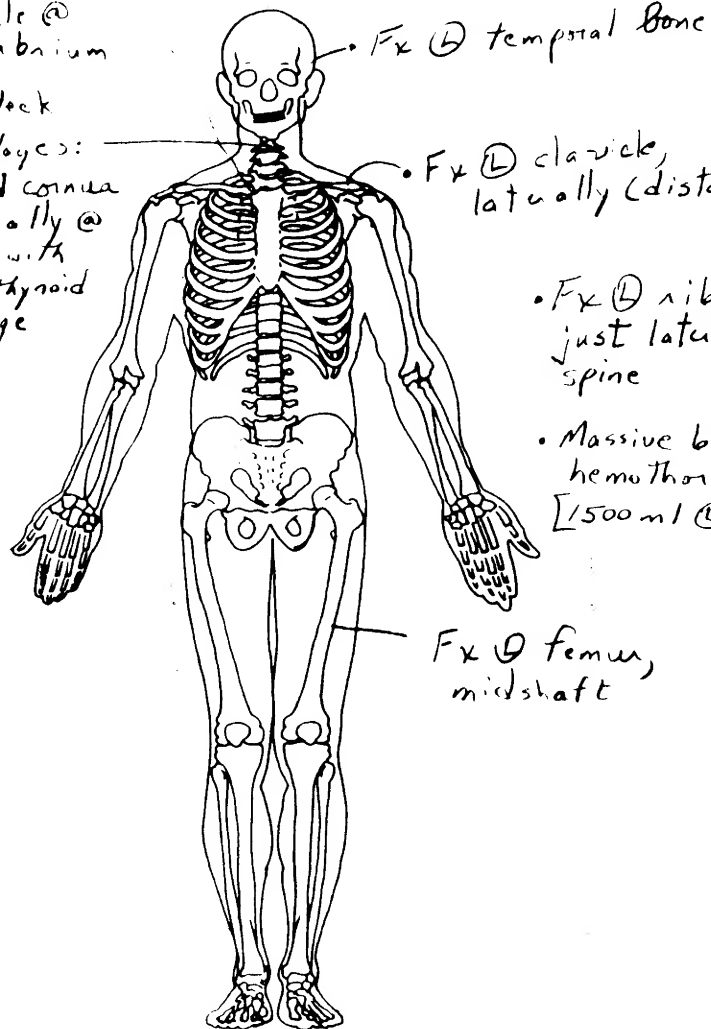
- Fx + dislocation (X)  
clavicle @  
manubrium

- Fx Neck  
Cervical:  
thyroid cartilage  
bilaterally @  
corner with  
body of thyroid  
cartilage

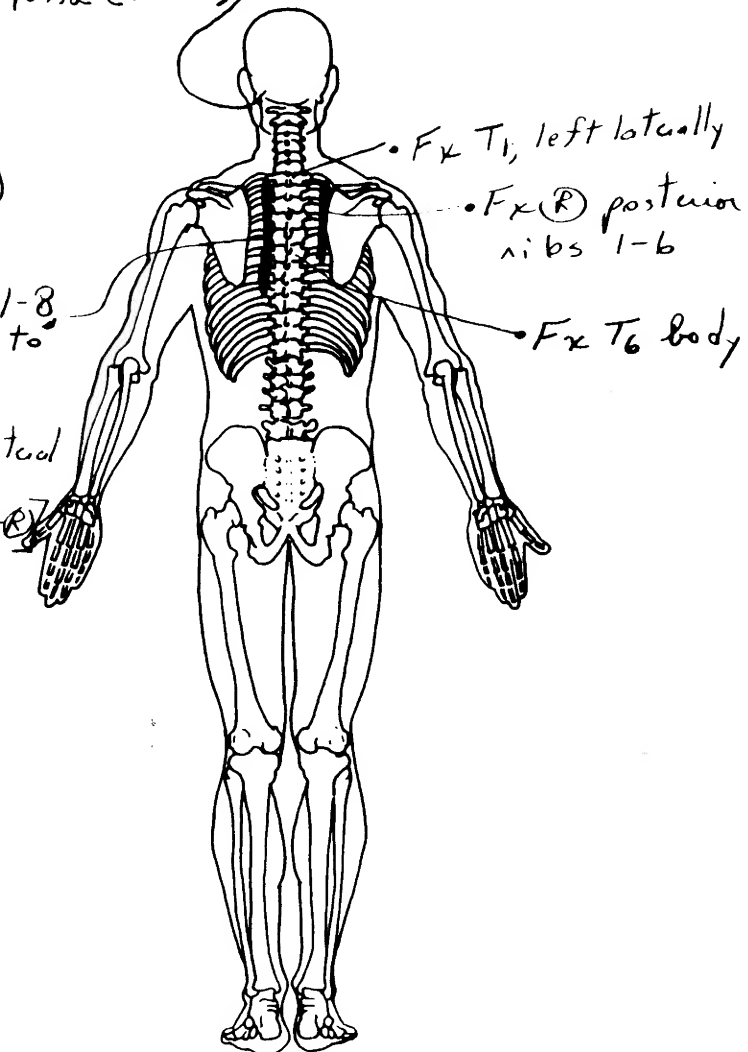
- Fx (L) posterior  
fossa (basilar)

- Fx (L) ribs 1-8  
just lateral to  
spine

- Massive bilateral  
hemothorax  
[1500 ml (L) + (R)]

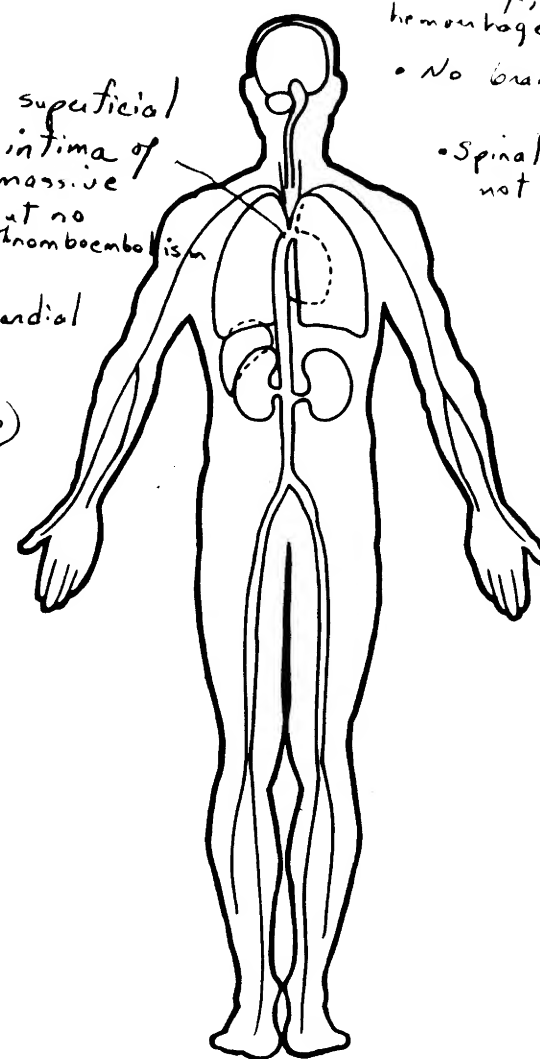
• Multiple superficial  
tears of intima of  
aorta; massive  
embolism but no  
pulmonary thromboembolism
